REFERENCE: SF-520016

PROJECT: 17BP.8.R.114

STRUCTURE
SUBSURFACE INVESTIGATION

COUNTY LEE
PROJECT DESCRIPTION BRIDGE NO.16 ON SR 1509
(SAN-LEE DR.) OVER LICK CREEK

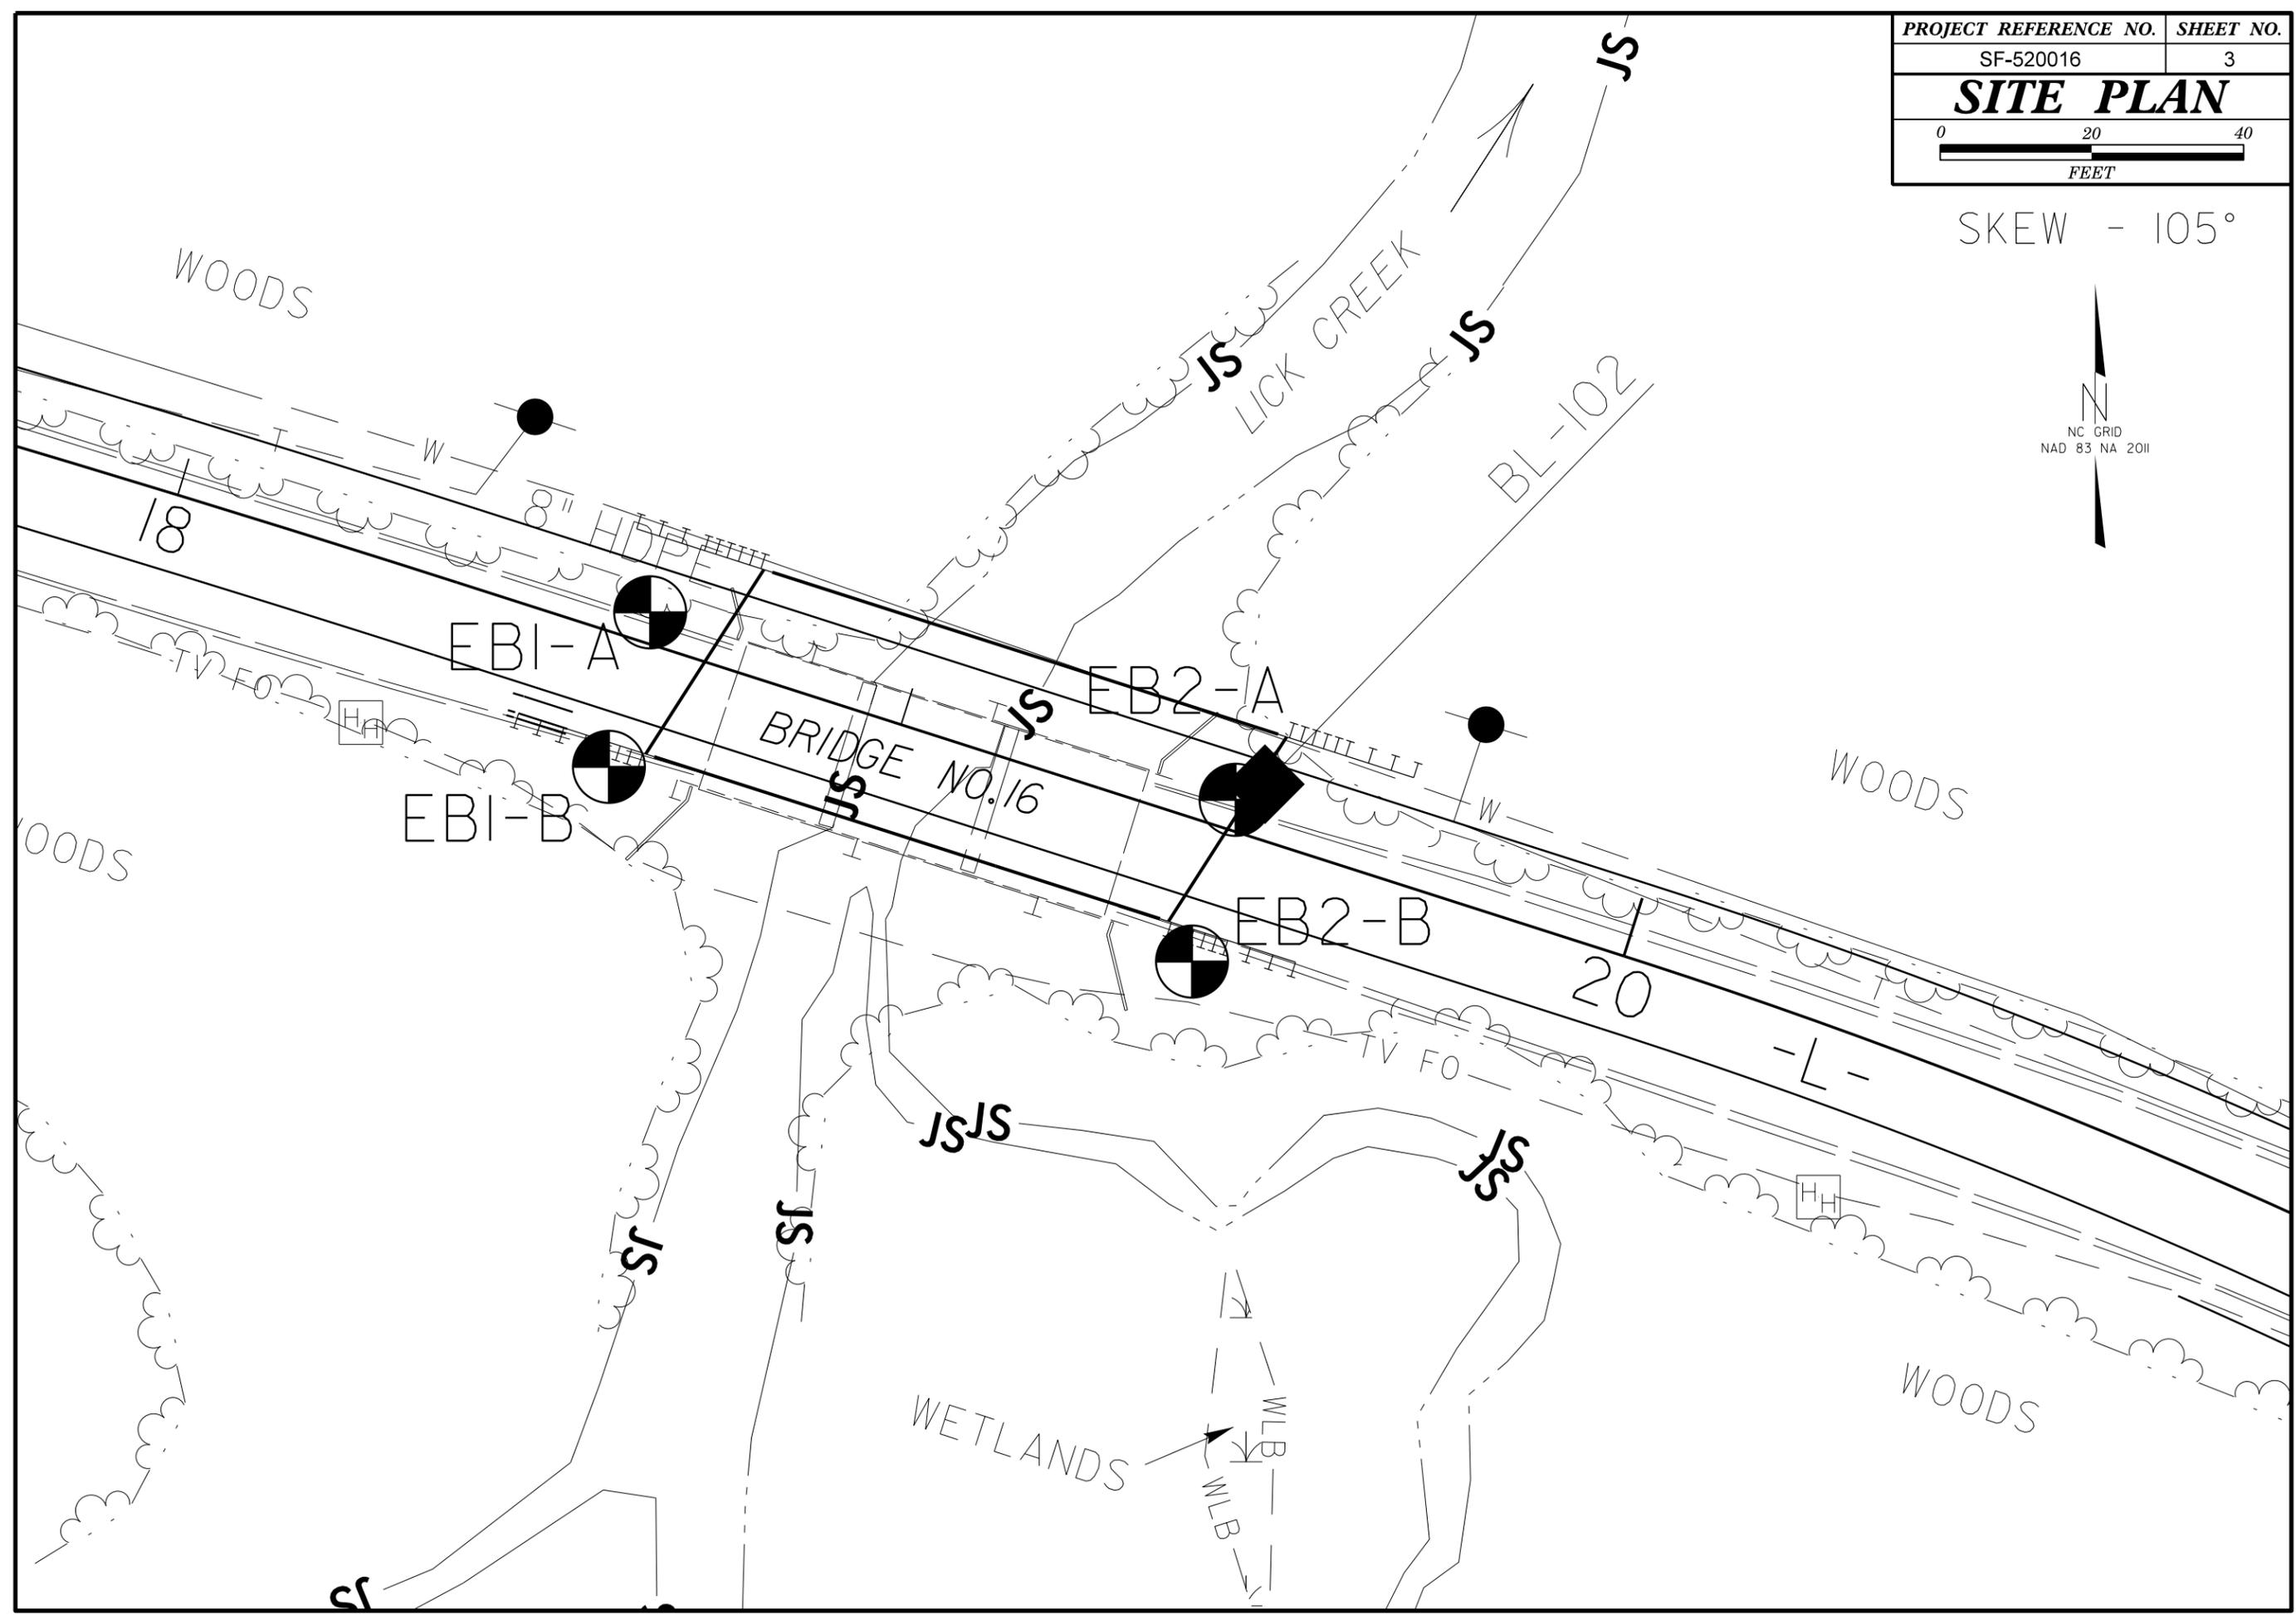
PROJECT REFERENCE NO.	SHEET NO.
SF-520016	3
SITE PLAN	
 0 20 40 FEET

SKEW - 105°

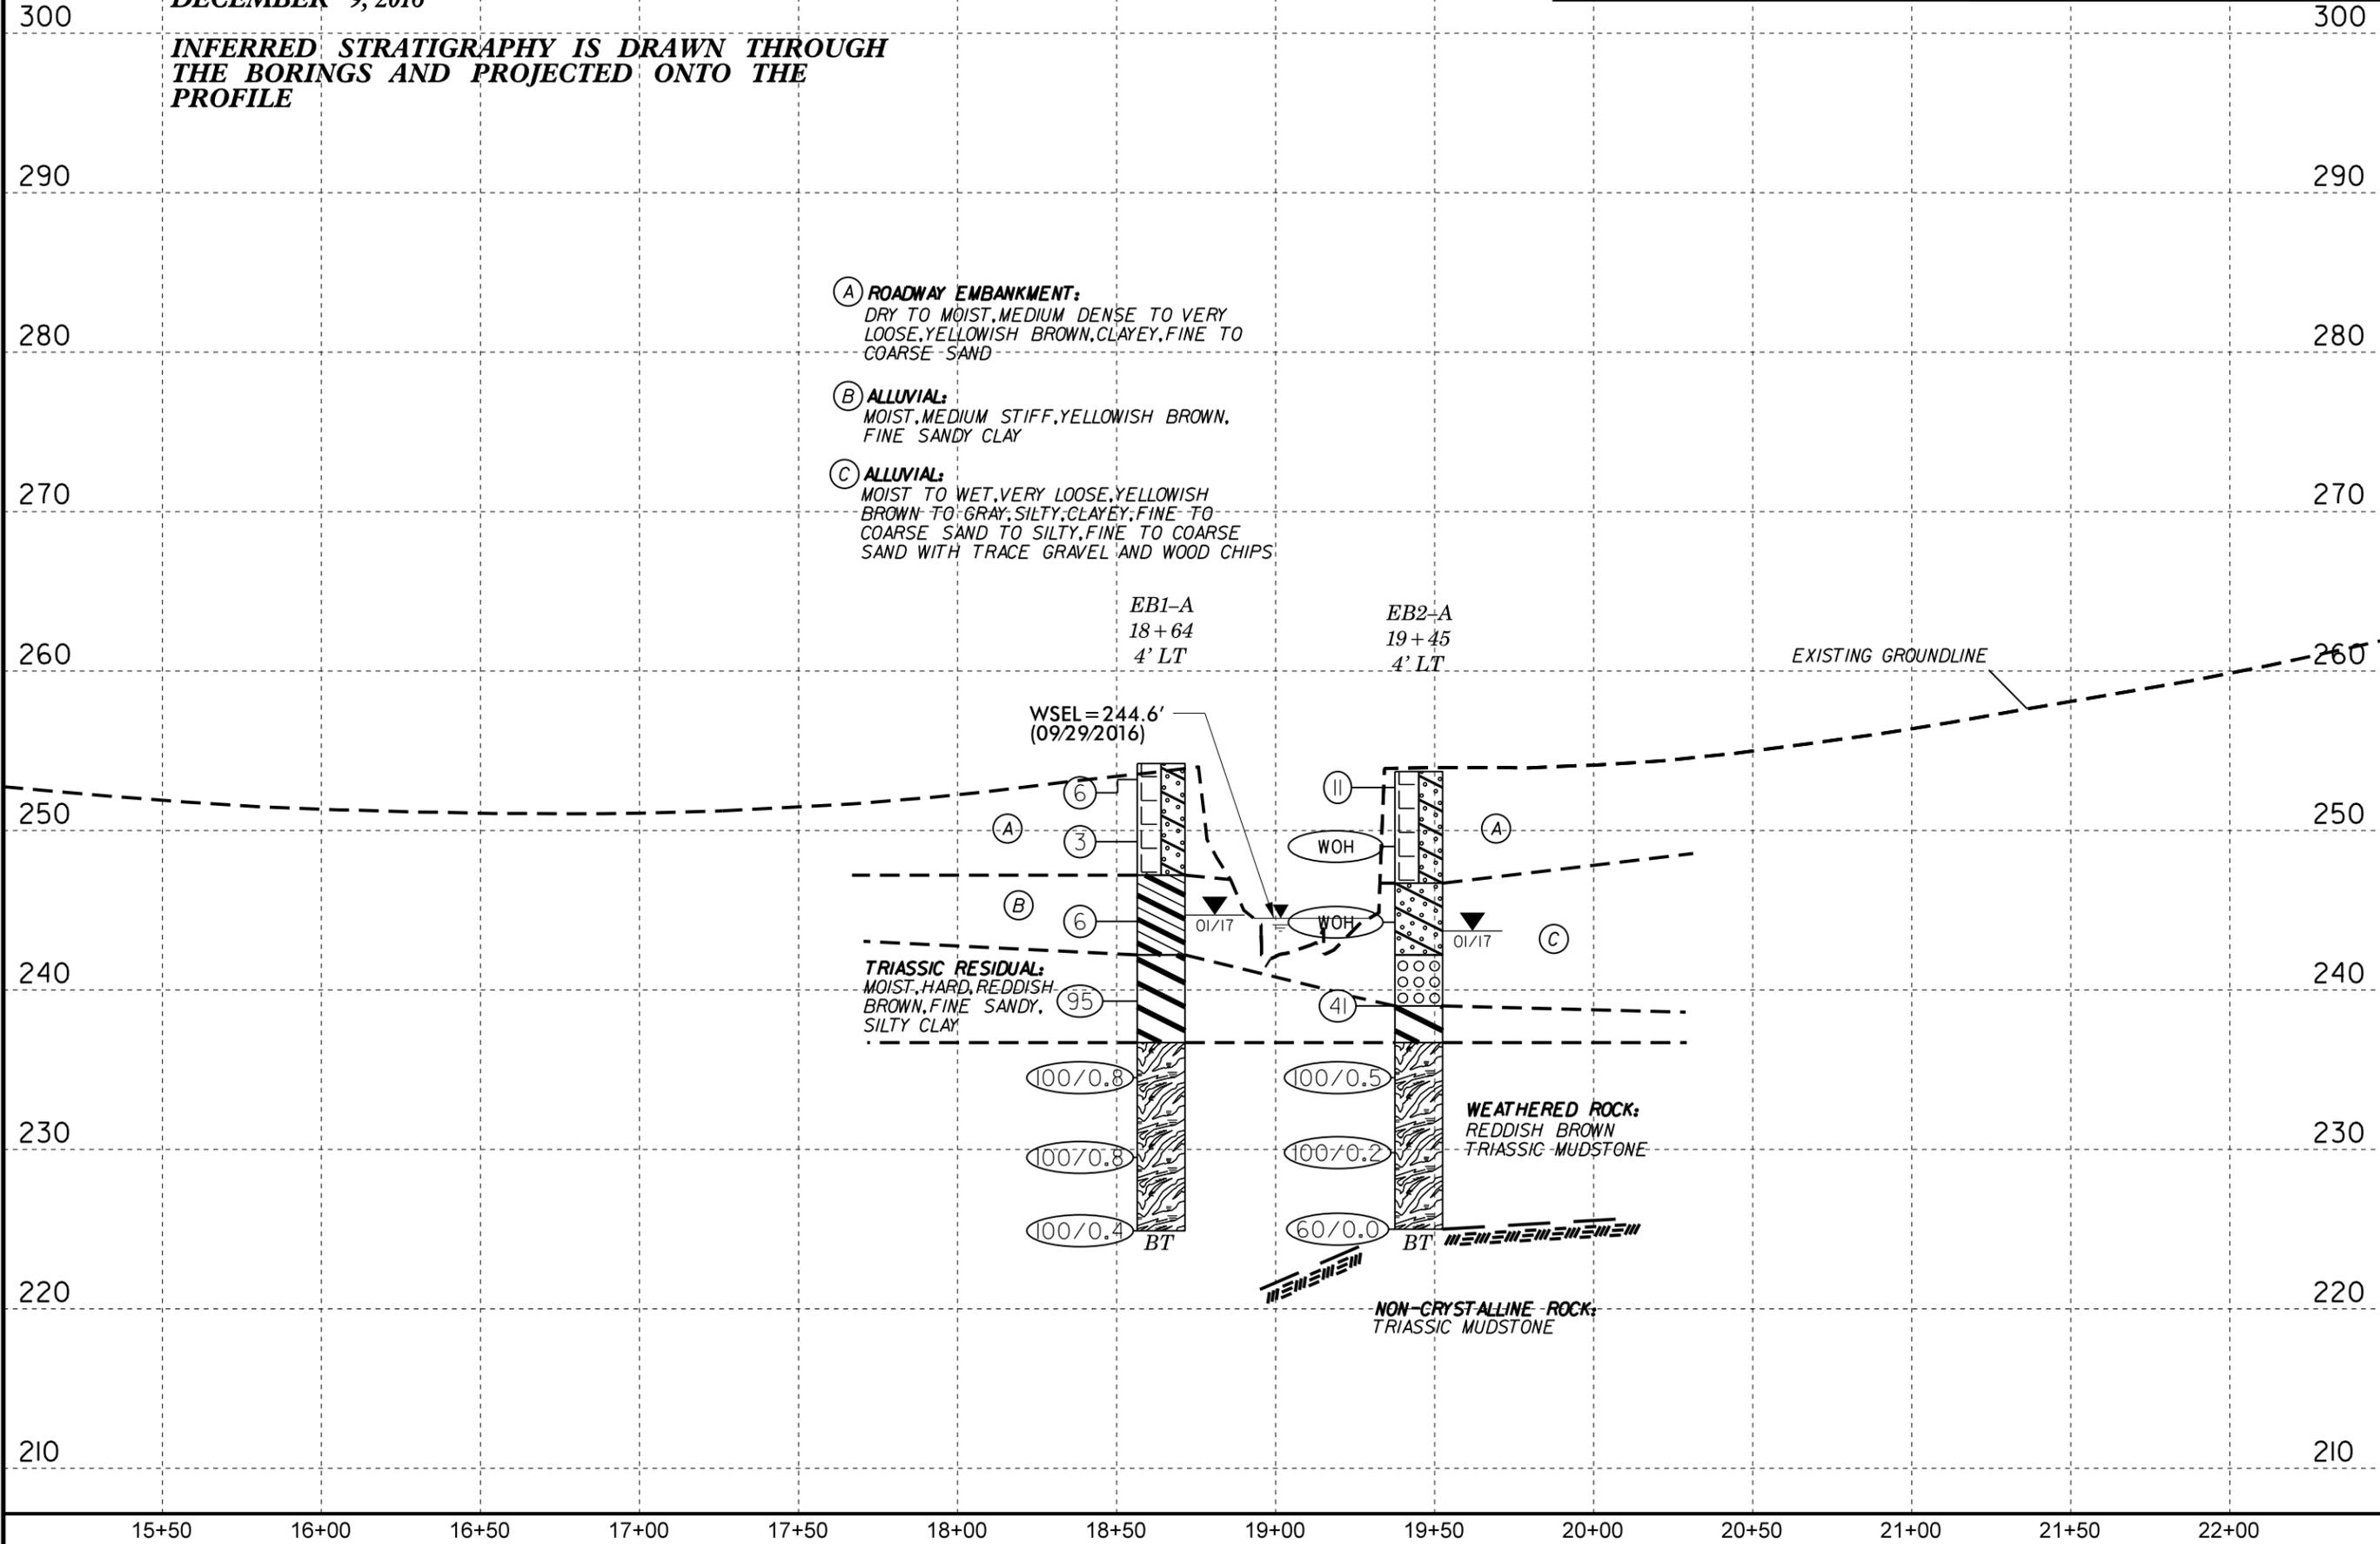
PROJECT REFERENCE NO.	SHEET NO.
SF-520016	4
BRIDGE NO 16 PROFILE ON -L-

NOTES:
GROUNDLINE TAKEN FROM ROADWAY DESIGN
TIN FILE 520016 LS_TNL.TIN RECEIVED ON
DECEMBER 9, 2016

INFERRED STRATIGRAPHY IS DRAWN THROUGH
THE BORINGS AND PROJECTED ONTO THE
PROFILE

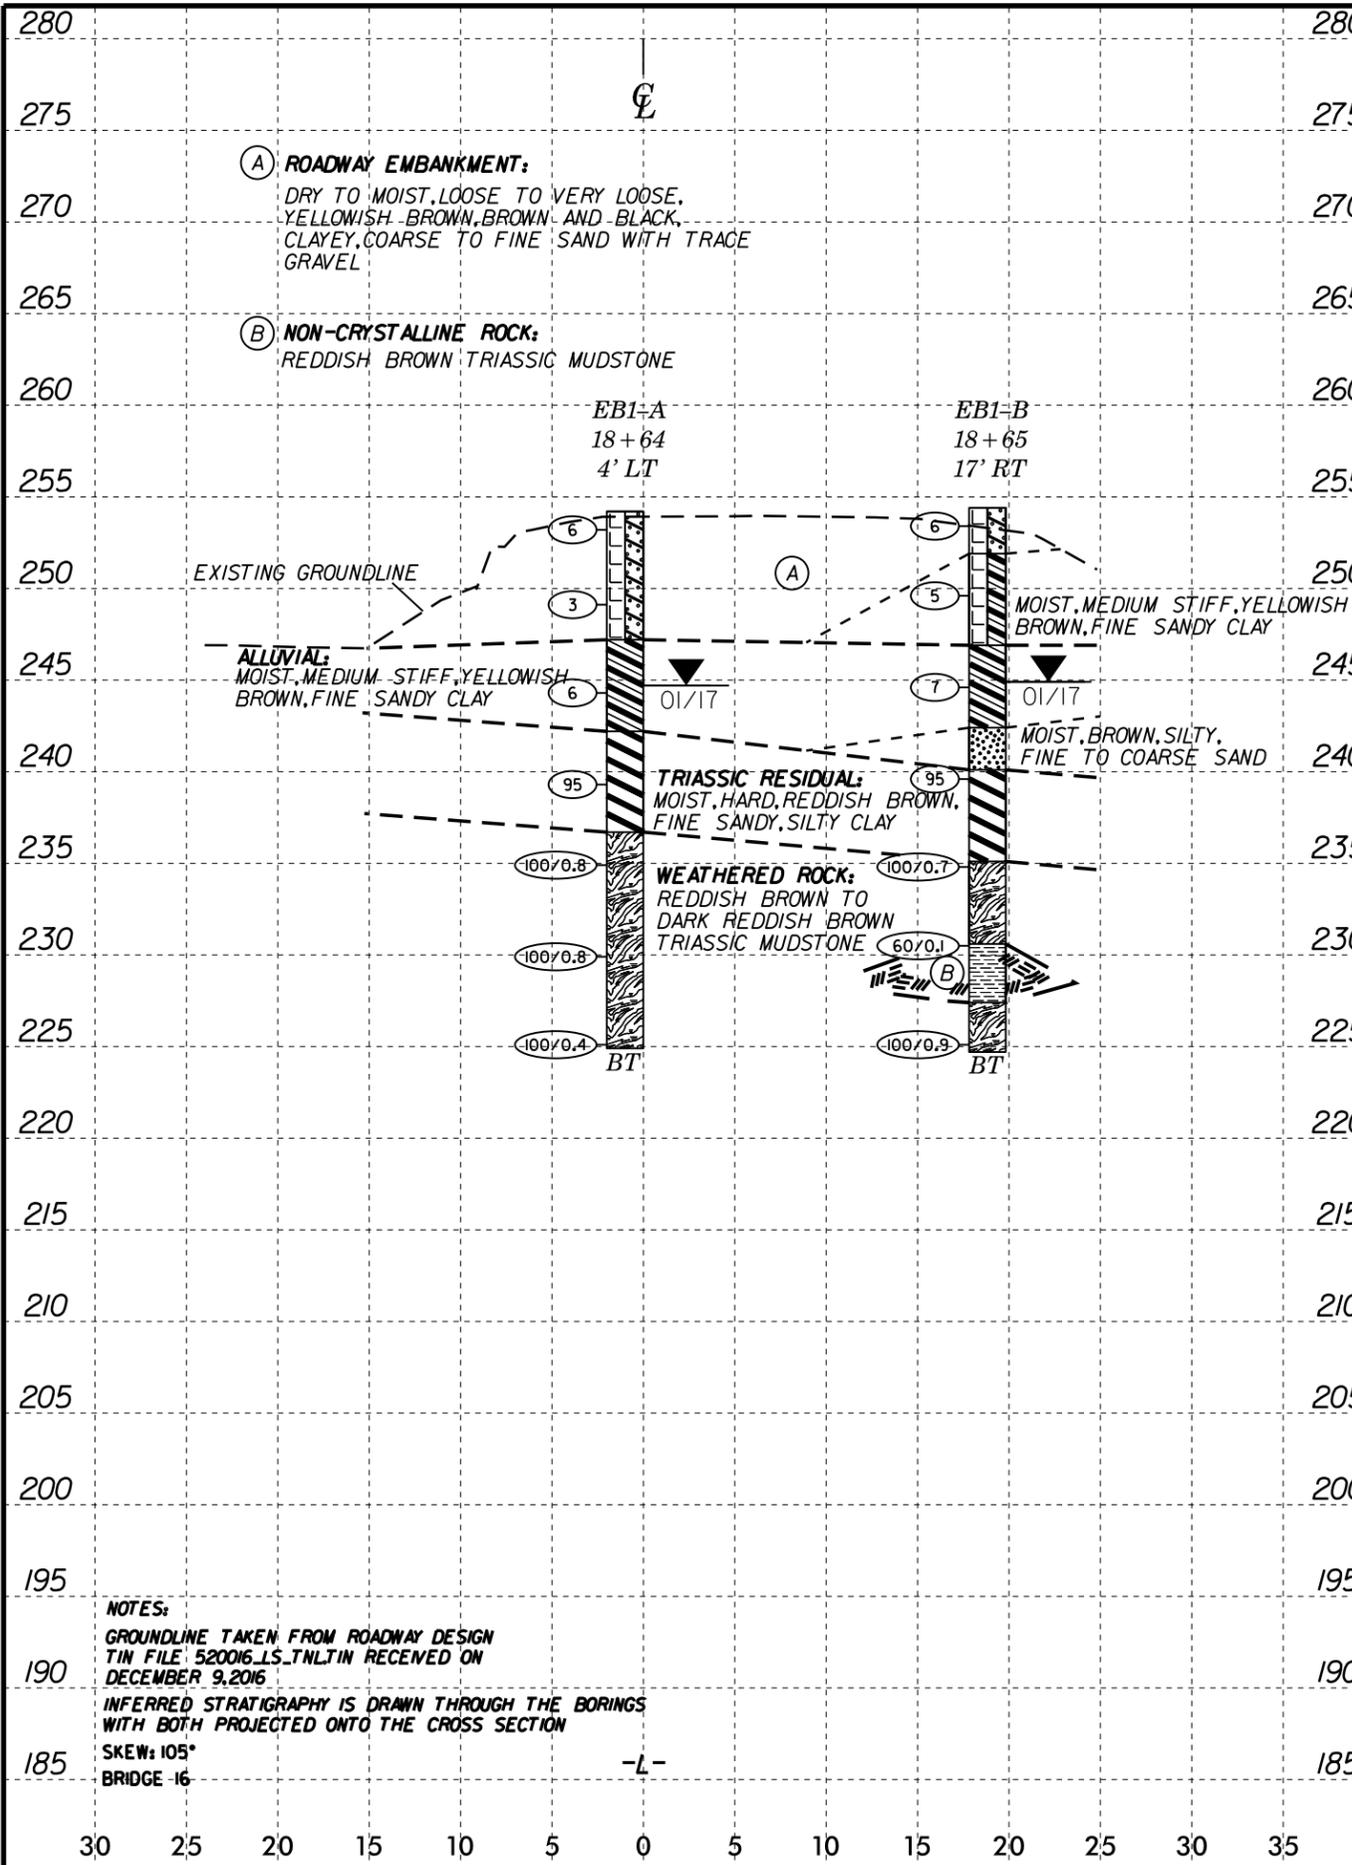
END BENT NO. 1 CROSS SECTION AT STA. 18+74

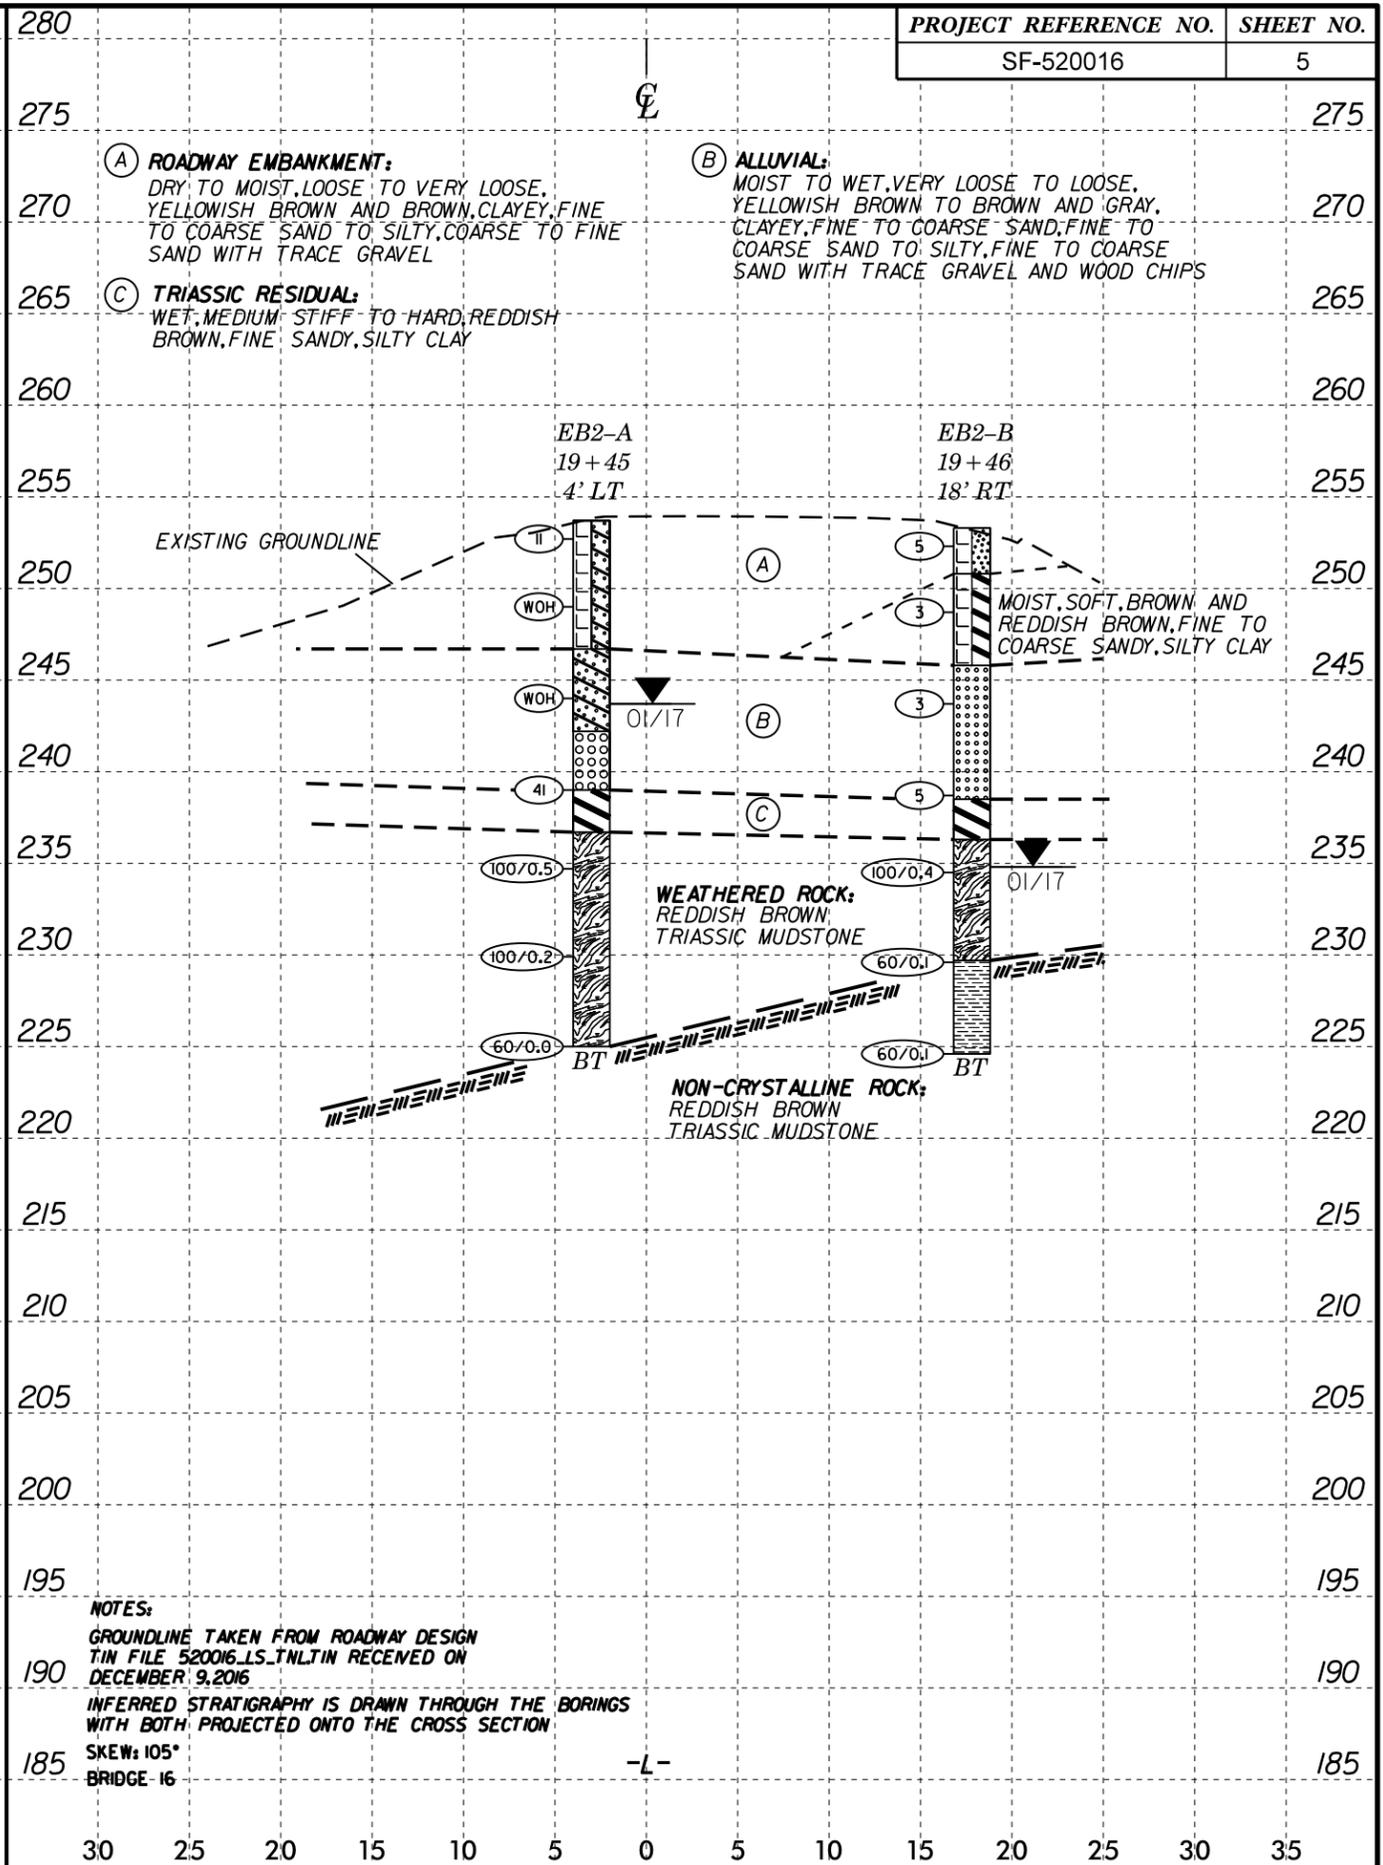
END BENT NO. 2 CROSS SECTION AT STA. 19+44

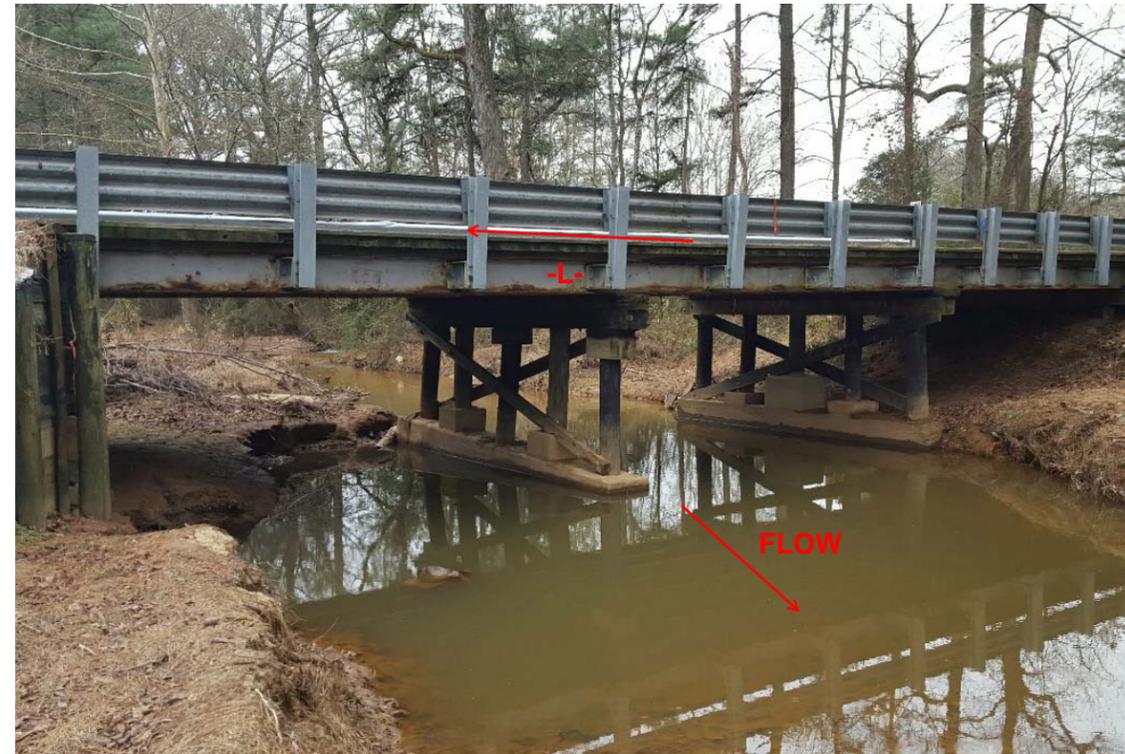
Profile of Existing Bridge from South of End Bent No. 2
